RE: **Annual Operation Report for 2023**
Frey Farm Landfill, Permit No. 101389

Sheet 1	2022 TOPOGRAPHIC SURVEY 2023 ANNUAL OPERATIONS REPORT MANOR TOWNSHIP LANCASTER COUNTY SOLID WASTE MANAGEMENT AUTHORITY LANCASTER COUNTY, PENNSYLVANIA	1" = 100' Date: 06/05/2024 Project No: 24011239 Scale in Feet: 0, 100, 200, 300	 ARM Group LLC Engineers and Scientists www.armgroup.net
-------------------	--	--	--

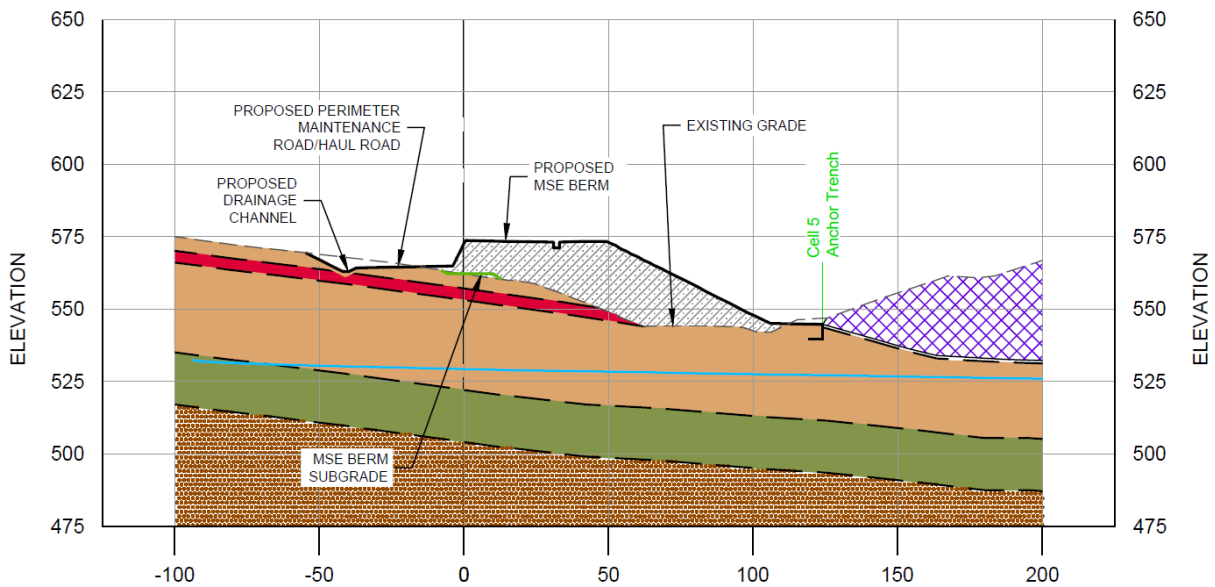
SECTION 21 (STA. 20+00.00)

It should be noted that the changes in elevation at STA 20+00 and 22+00 along the toe of the berm do show more significant settlement than the rest of the monitoring points. The settlement is likely due to the phasing and sequencing of construction. After the MSE berm was constructed, additional structural fill was placed along the face of the MSE berm in this area to construct the new landfill haul road. Therefore, the control monuments were installed within the additional structural fill, which is more prone to settlement than the MSE berm, especially at the interface of the MSE berm and structural fill, where compaction of the subsequently placed structural fill would be more difficult due to the presence of the MSE berm welded wire forms. Below are two cross-sections at STA 20+00 and 22+00 showing the bottom of the MSE berm and the structural fill placed along the outside of the MSE berm.

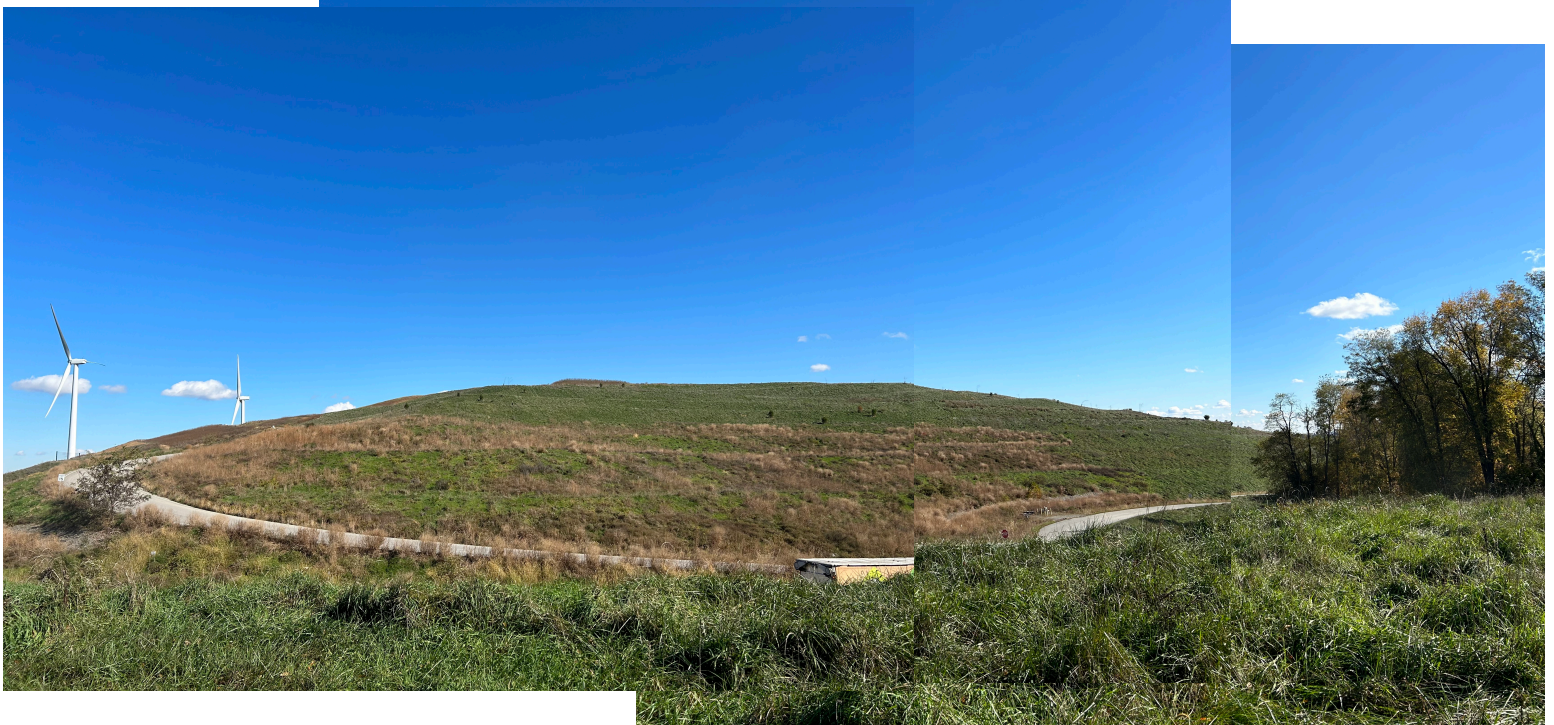
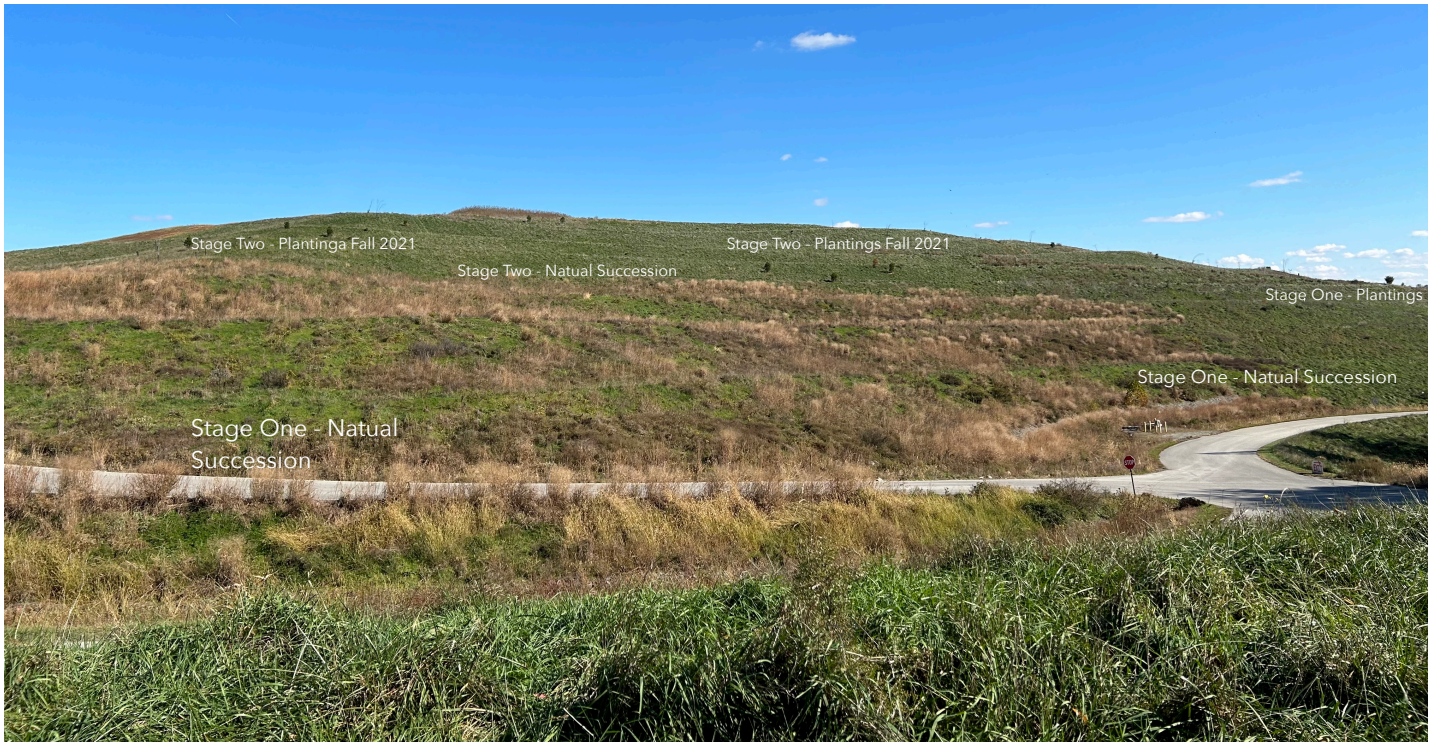
Stage One and Two
Photos Taken During
November 2023 Inspection
