RE: **Annual Operation Report for 2023**
Frey Farm Landfill, Permit No. 101389

Sheet 1	2022 TOPOGRAPHIC SURVEY 2023 ANNUAL OPERATIONS REPORT MANOR TOWNSHIP LANCASTER COUNTY SOLID WASTE MANAGEMENT AUTHORITY LANCASTER COUNTY, PENNSYLVANIA	1" = 100' Date: 06/05/2024 Project No: 24011239 Scale in Feet: 0, 100, 200, 300	 ARM Group LLC Engineers and Scientists www.armgroup.net
-------------------	--	--	--

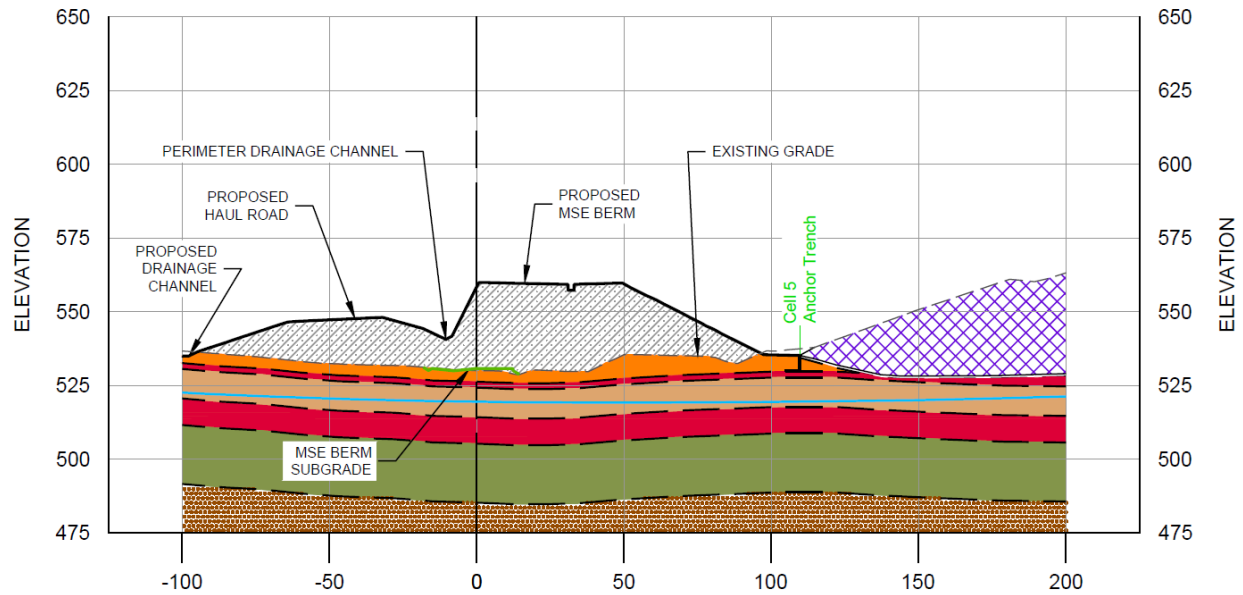
SECTION 21 (STA. 20+00.00)

It should be noted that the changes in elevation at STA 20+00 and 22+00 along the toe of the berm do show more significant settlement than the rest of the monitoring points. The settlement is likely due to the phasing and sequencing of construction. After the MSE berm was constructed, additional structural fill was placed along the face of the MSE berm in this area to construct the new landfill haul road. Therefore, the control monuments were installed within the additional structural fill, which is more prone to settlement than the MSE berm, especially at the interface of the MSE berm and structural fill, where compaction of the subsequently placed structural fill would be more difficult due to the presence of the MSE berm welded wire forms. Below are two cross-sections at STA 20+00 and 22+00 showing the bottom of the MSE berm and the structural fill placed along the outside of the MSE berm.

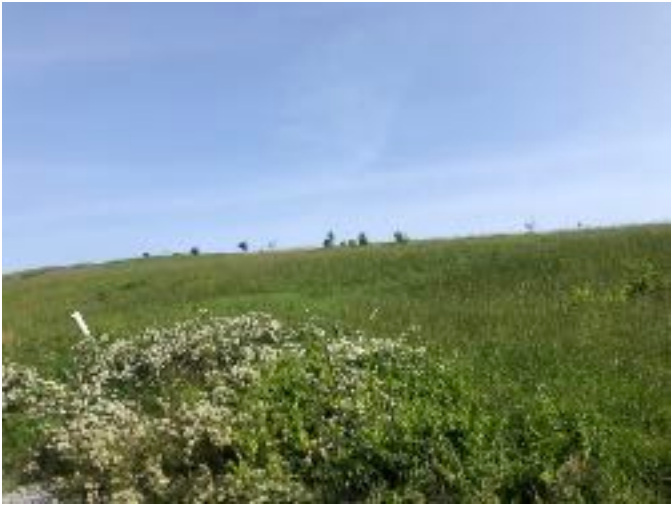
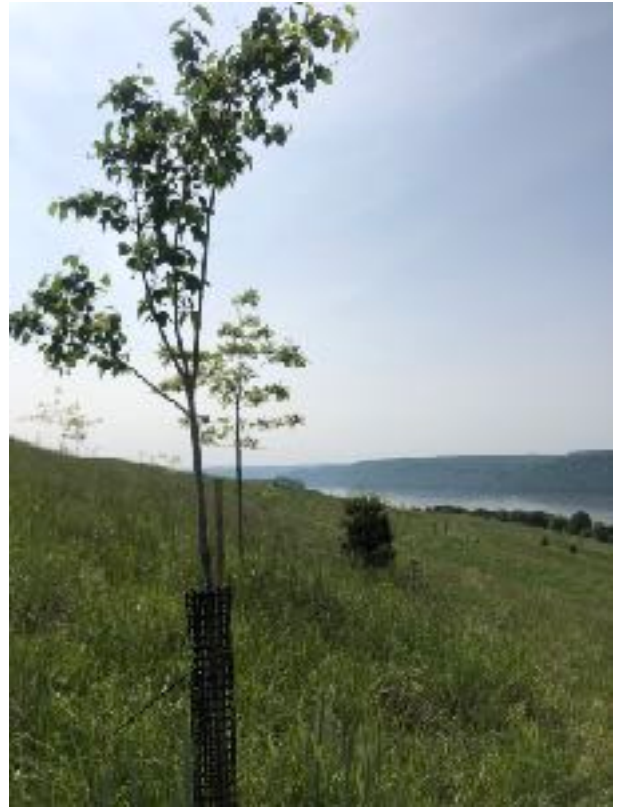
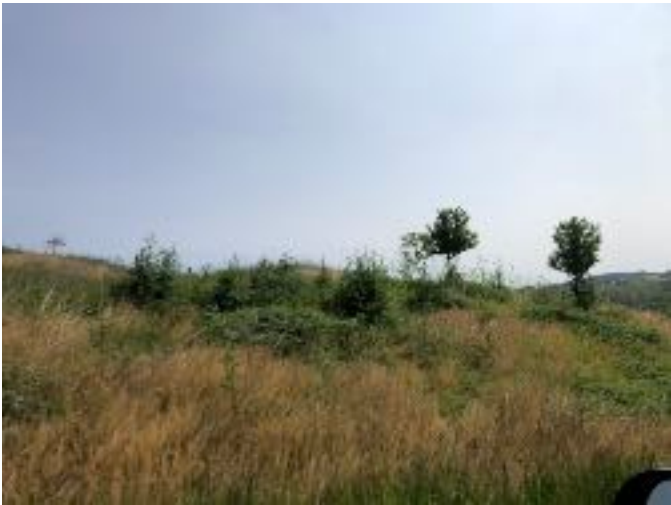
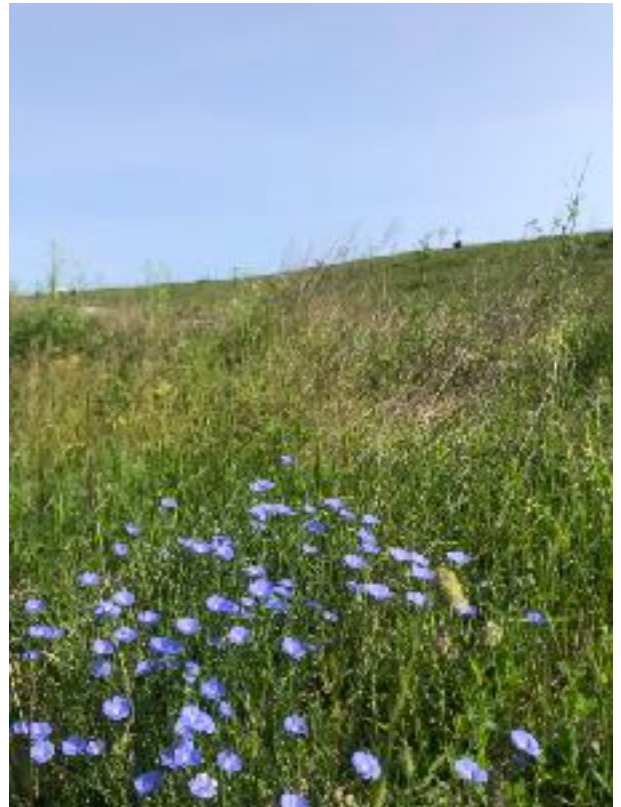
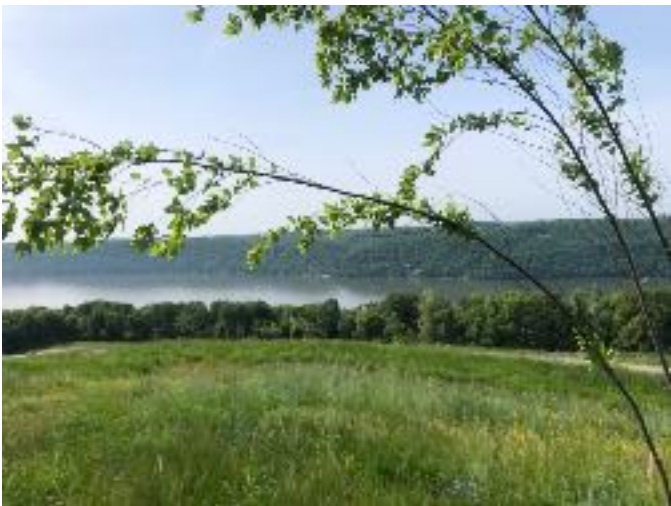
Stage One and Two
Photos Taken During
May 2023 Inspection

Larger deer guards were added to try and create additional protection. Deer guards were added to all Stage 2 plants concurrent with the October implementation. Still it will be likely be difficult to mitigate all deer damage.

Natural succession zone ranges 18"-72"+ in height. Slopes appear full with grasses thriving. Visual softening of benching and greater visual appeal continue to be extremely successful when contrasted with traditional mowed slope aesthetic. Some natural succession of locust, cherry and multiflora rose, american pokeweed was observed in natural succession area. I believe we will continue to see the "natural succession" area do well.

Not recommending replacing plants within Stage 1 planting.

Monitor dry conditions.
